PEAK ACCELERATION DEVICE (PAD)

Paul Ibanez, John F. Gray

Final Report for Period April 1985 - December 1986

AVIATION APPLIED TECHNOLOGY DIRECTORATE

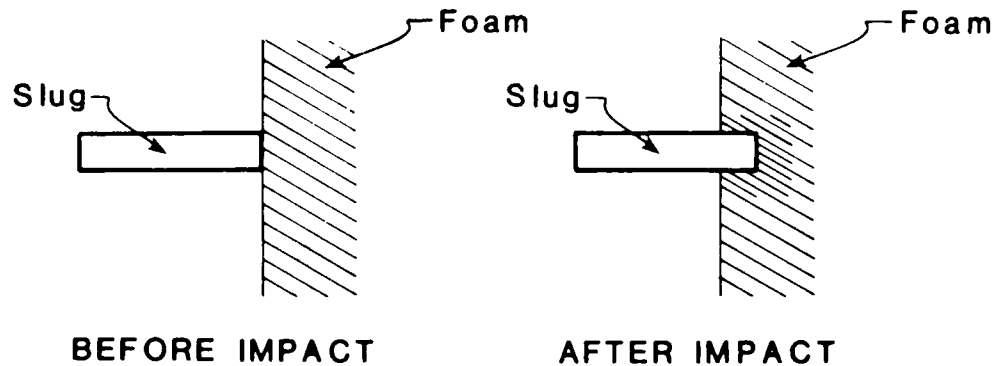
Figure 2. Principle of rod-foam concept.

The initial Phase II work pursued the cylindrical rod-phenolic foam concept found promising in Phase I (see Figure 2).

3
F
Considerations of device size and weight mandated that a crushable foam material possessing 1/5 of the compressive strength of the foam tested in Phase I be used in the final design. Although a material with this characteristic could not be located, it became apparent that a material with such low strength would be unsuitable for the application for other reasons. These include fretting between it and the cylindrical slugs, questionable resistance to environmental degradation over an extended period, and the manufacturing difficulties associated with fragile materials. This led to the examination of metallic foils as an alternative implementation of the same basic approach.

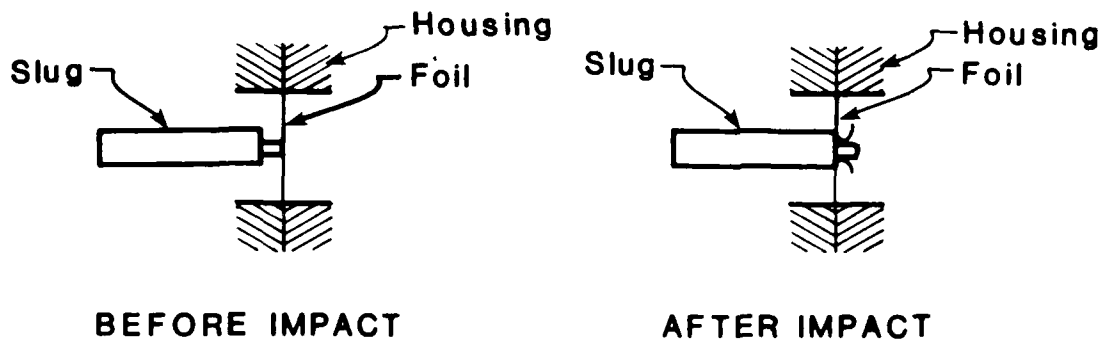
Figure 3. Principle of slug-foil concept.

This concept replaced the crushable foam with a thin metallic foil which was to be penetrated under impact by cylindrical rods with stepped or pointed ends (slugs). It was anticipated that once a suitable foil material and thickness was determined, slug end-geometry could be varied to permit the desired range of "g" values to be indicated. Extensive dynamic and static testing was conducted with a variety of foils of different compositions and thicknesses in conjunction with slugs of differing weights and end geometries in an effort to find a satisfactory combination.

A variety of stainless steel foil thicknesses between 0.003 and 0.0002 in. were investigated. It was concluded that the 0.0002-inch foil was the minimum thickness that would be practical for use in the final design. Slugs with both stepped (Type A) and conical (Type B) points were evaluated. These two profiles are illustrated in Figure 4. Initially, the Type A profile was considered to be the more attractive, as it was believed that slug masses could all be similar, and only the ratio of outside to step diameter varied to give the desired range of "g" indications. Anticipated stress values calculated from a formula which applies to "circular plates clamped at their circumference and concentrically loaded" indicated that such an arrangement should be viable.

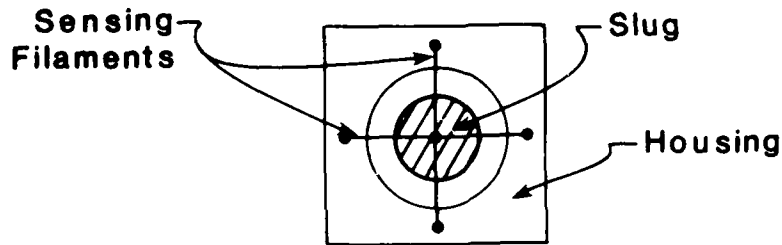
Figure 5. Principle of slug-filament concept.

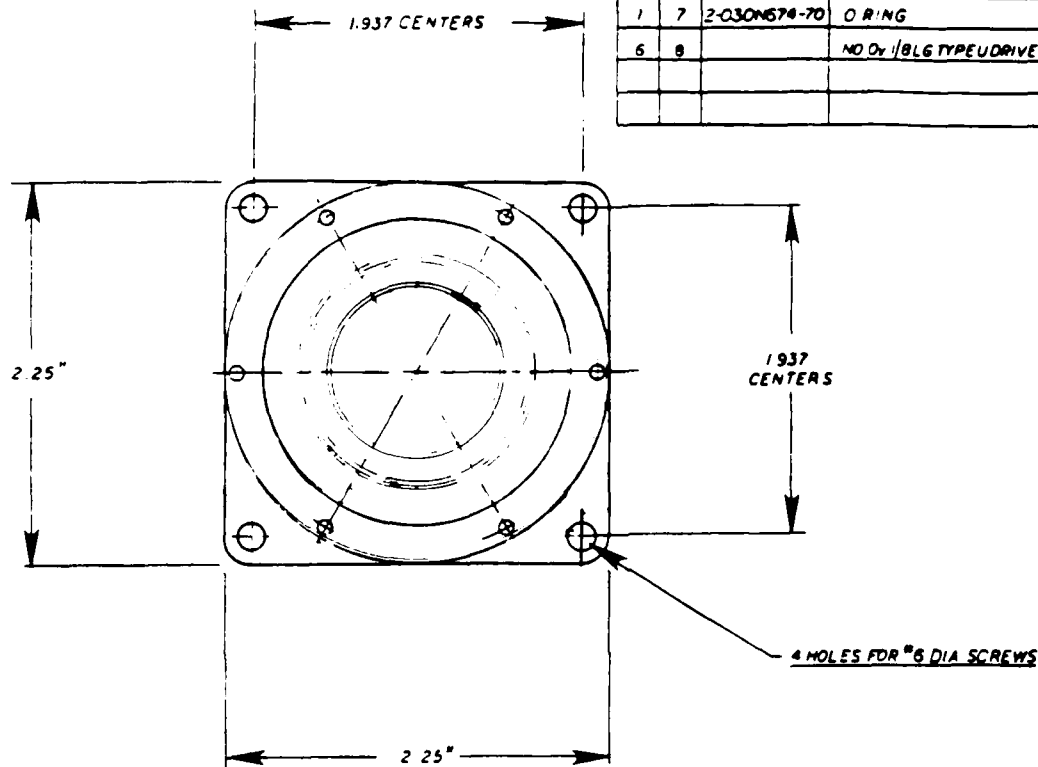
Figure 6. Peak acceleration device.

The final configuration of the Peak g indicator is illustrated by Figure 6. It generally conforms to the target criteria set forth in the technical abstract of the contract. It has the capability to measure impacts of 15-100 g in each of three axes, will fit within a 2-1/4-in. cube, has a mechanical filter system that isolates the indicating cube from the majority of impact energy at frequencies above 100 Hz, and is housed in a rugged aluminum casing that provides high resistance to mechanical damage. The total weight of the device is less than 7 ounces. A maximum weight limitation was not specified in this proposal; however, a target value of 8 ounces was established informally and used as a design parameter.

The indicating cube is suspended within an aluminum housing by two conical compression springs. The void between the cube and housing is filled with SAE 80-90 weight silicone oil. This mechanism provides the desired triaxial filtering of impact energy at frequencies above 100 Hz. The housing is of two-piece construction, the cover and O-ring gasket being attached to the body with drive screws. This provides a leak-free, tamper-proof package which is only intended to be opened for crash impact evaluations.

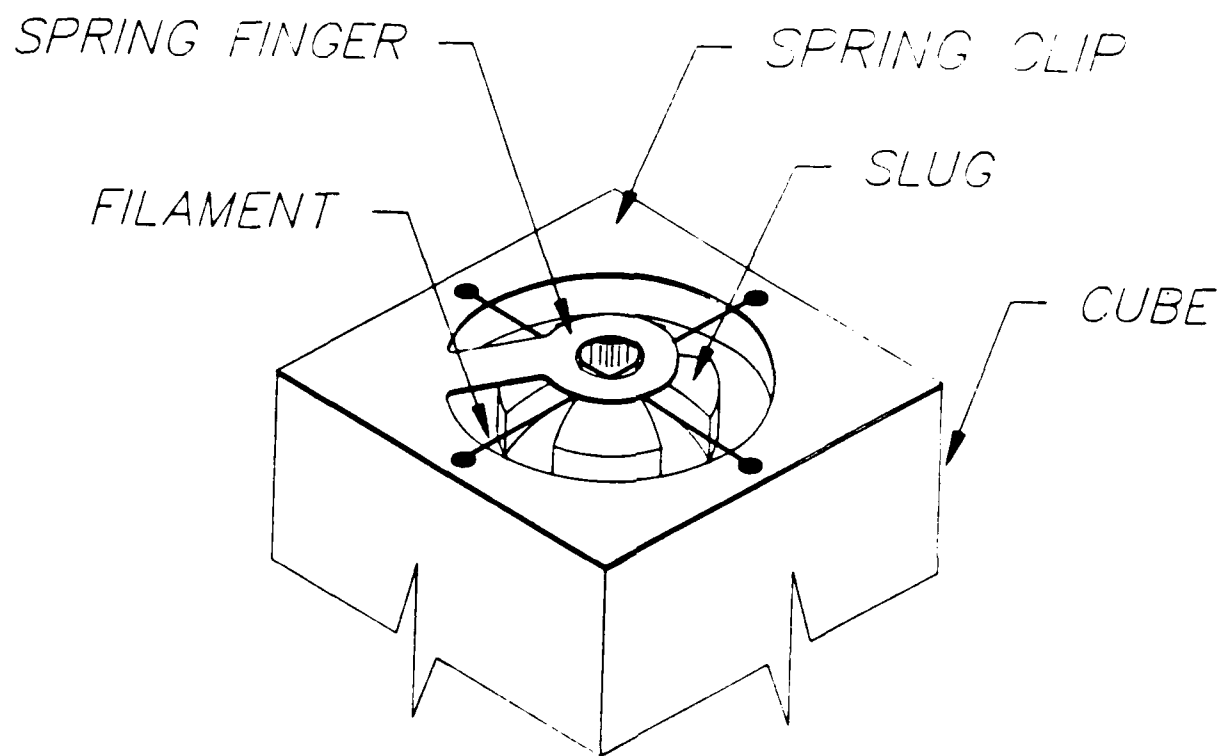
Figure 7. Spring clip arrangement.

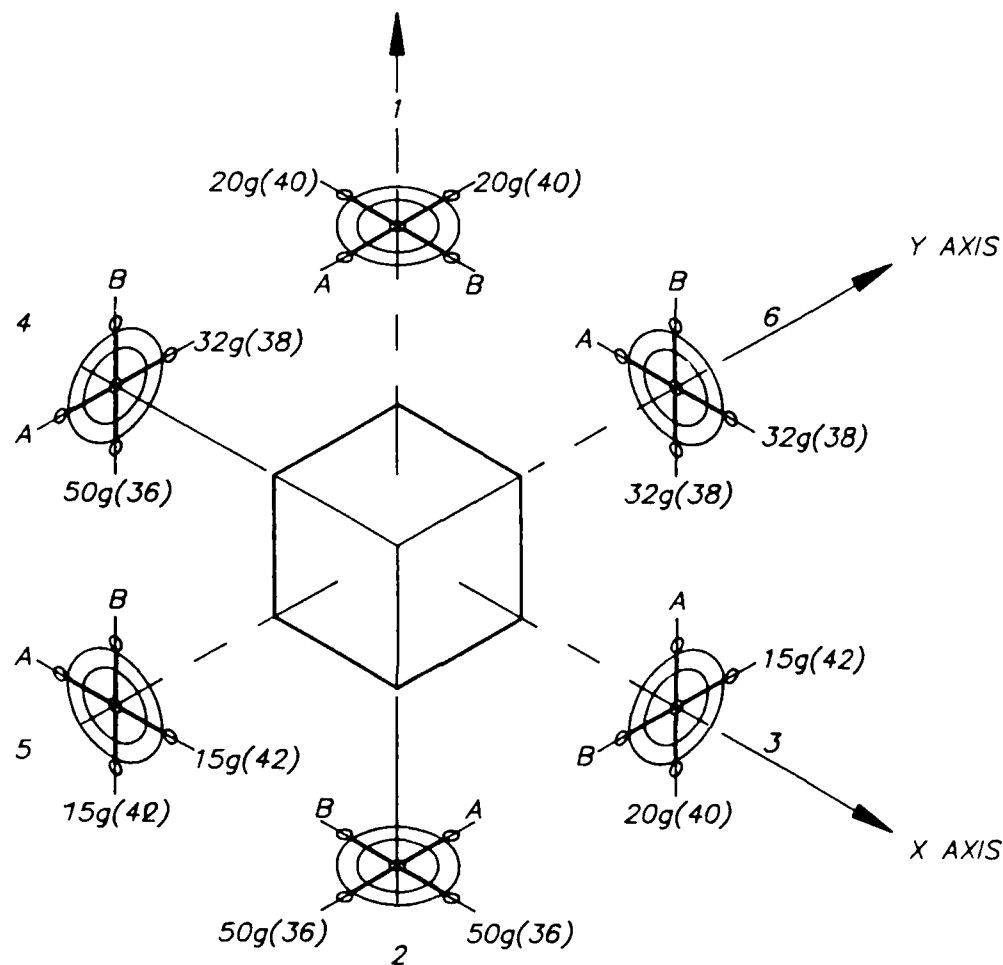
Figure 8. Slug-sensing wire arrangement.

Calculations based on wire strength, slug weight, the observed influence of strain rate, and the planned frictional constraint of the spring finger, suggested that 4 gages of wire (42, 40, 38 and 35) would be required to span the 15-100 g indicating range. These sizes were adopted subject to verification by testing, it being a simple matter to change to the intermediate sizes should test results mandate. Each slug has two sensing wires arranged at 90 degrees. The cube has a total complement of six slugs, each sensing a pair of values, thereby providing the twelve indications required by the triaxial device. Figure 8 illustrates this arrangement and indicates the axis-g range relationships.

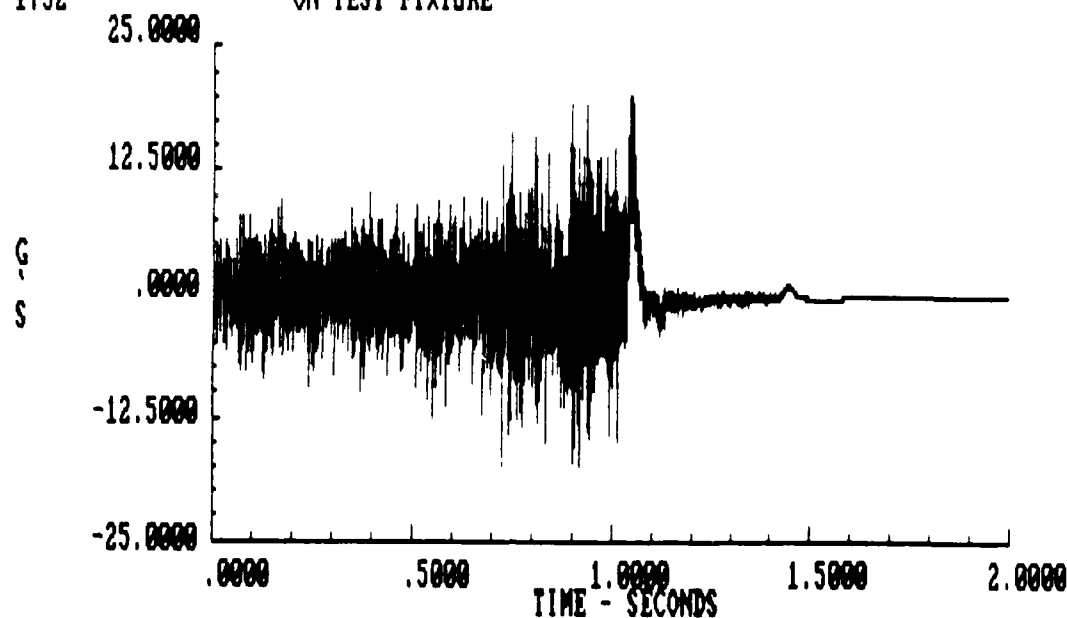
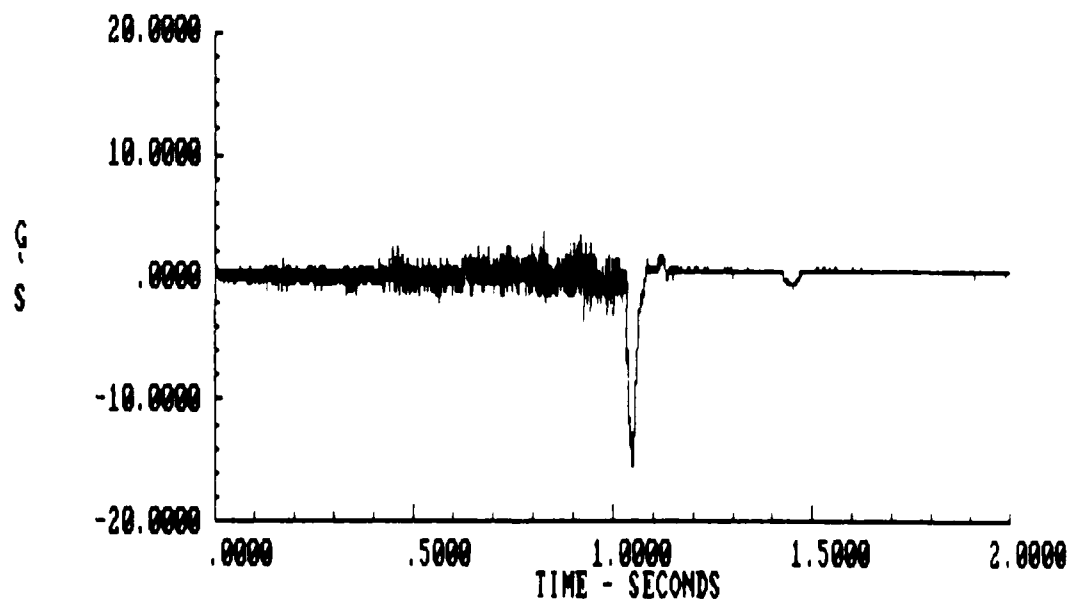
Figure 9. Z-axis impact time history (low g).

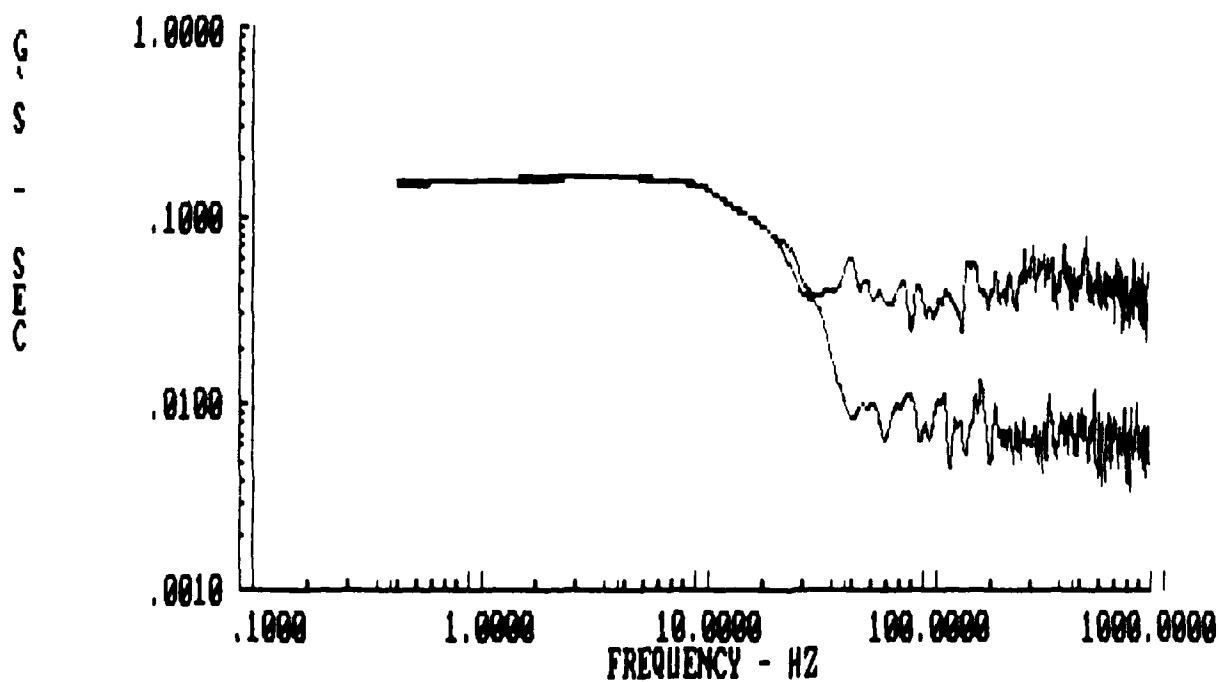
Figure 10. Fourier transforms (low g impact).

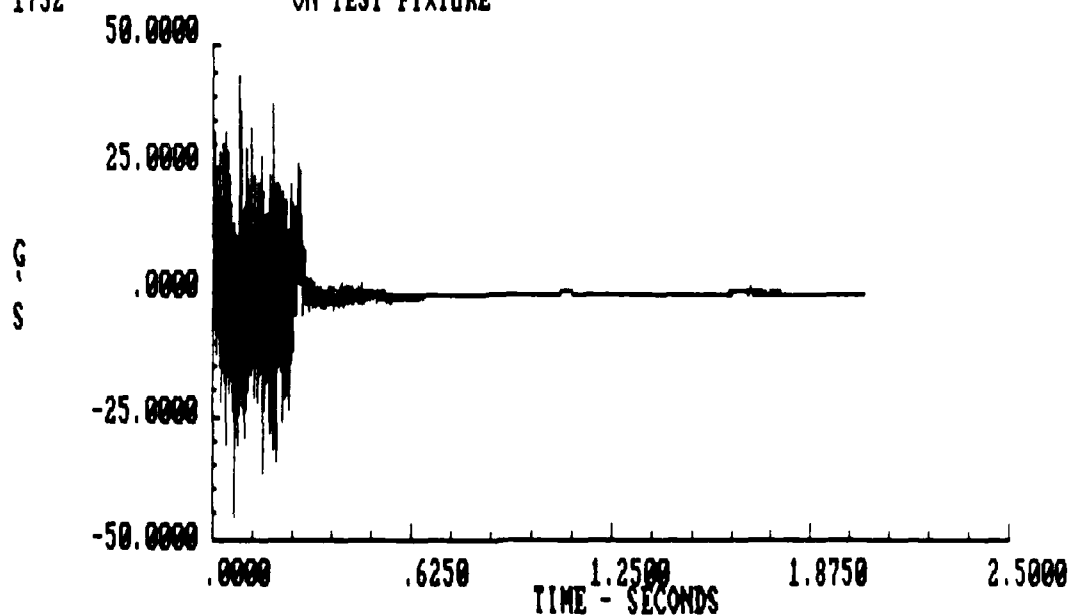
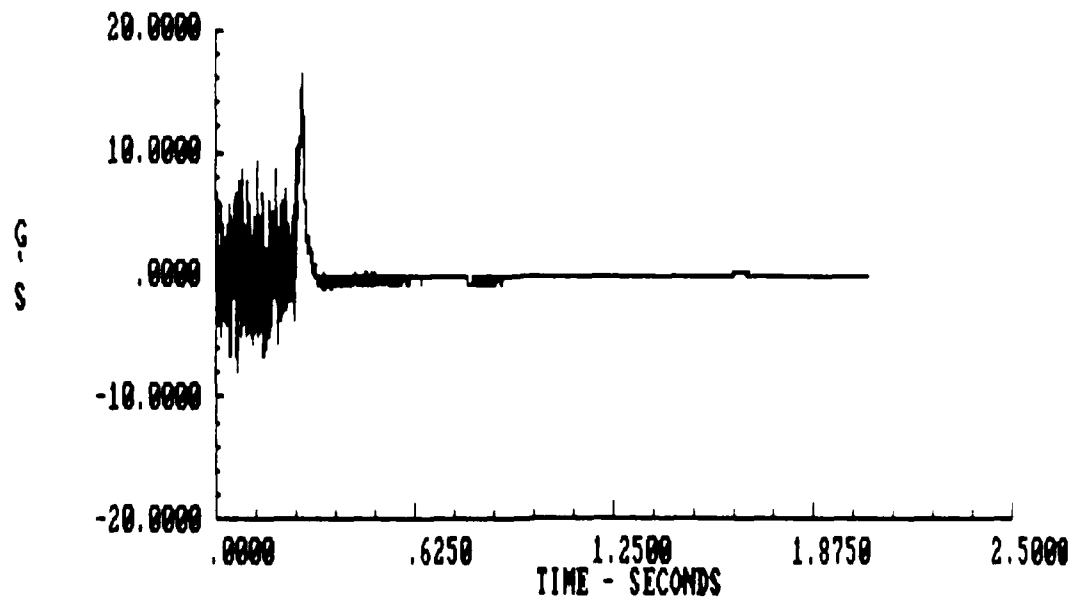
Figure 11. Z-axis impact time history (high g).

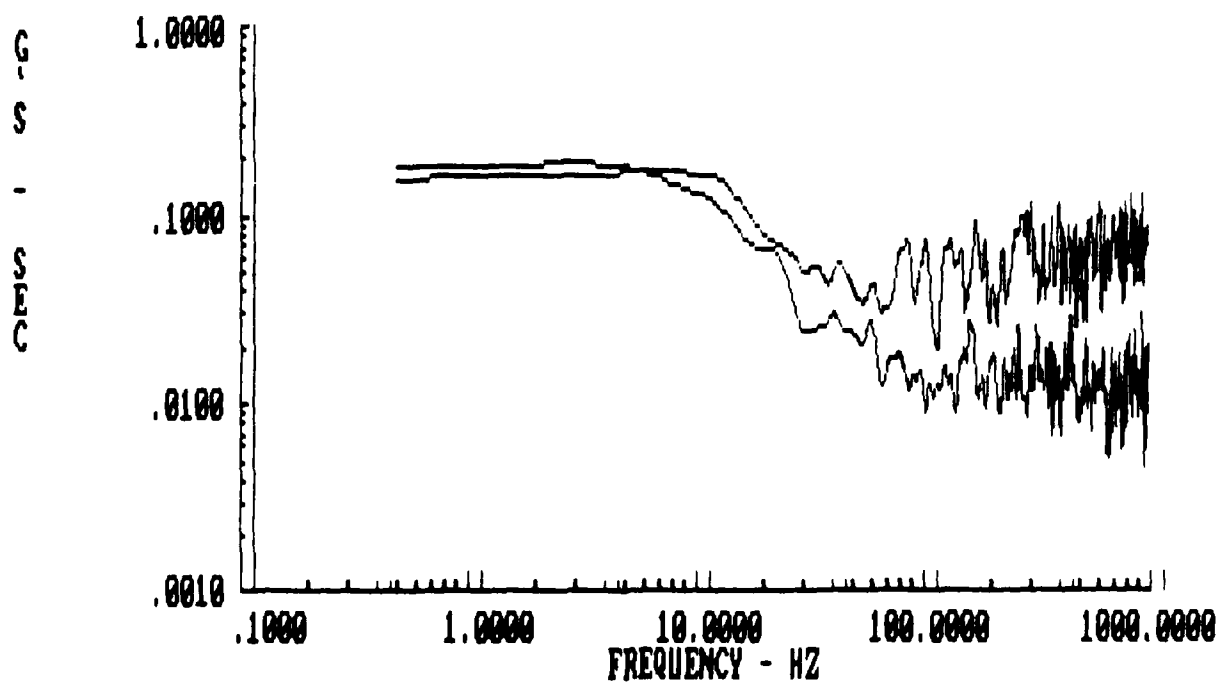
Figure 12. Fourier transforms (high g impact).

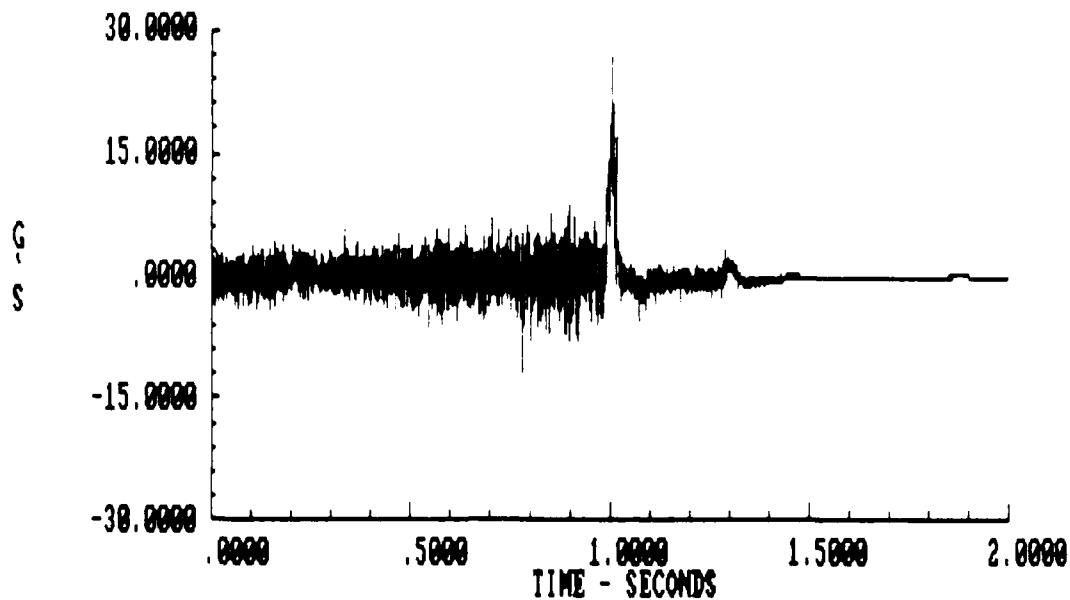
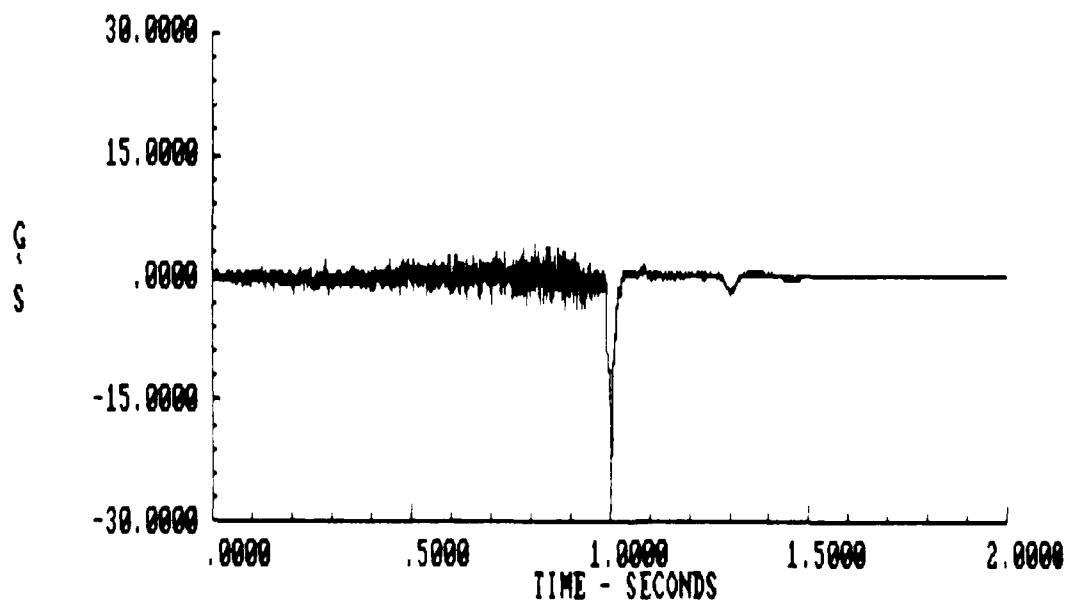
Figure 13. X-Y axis time history (low g impact).

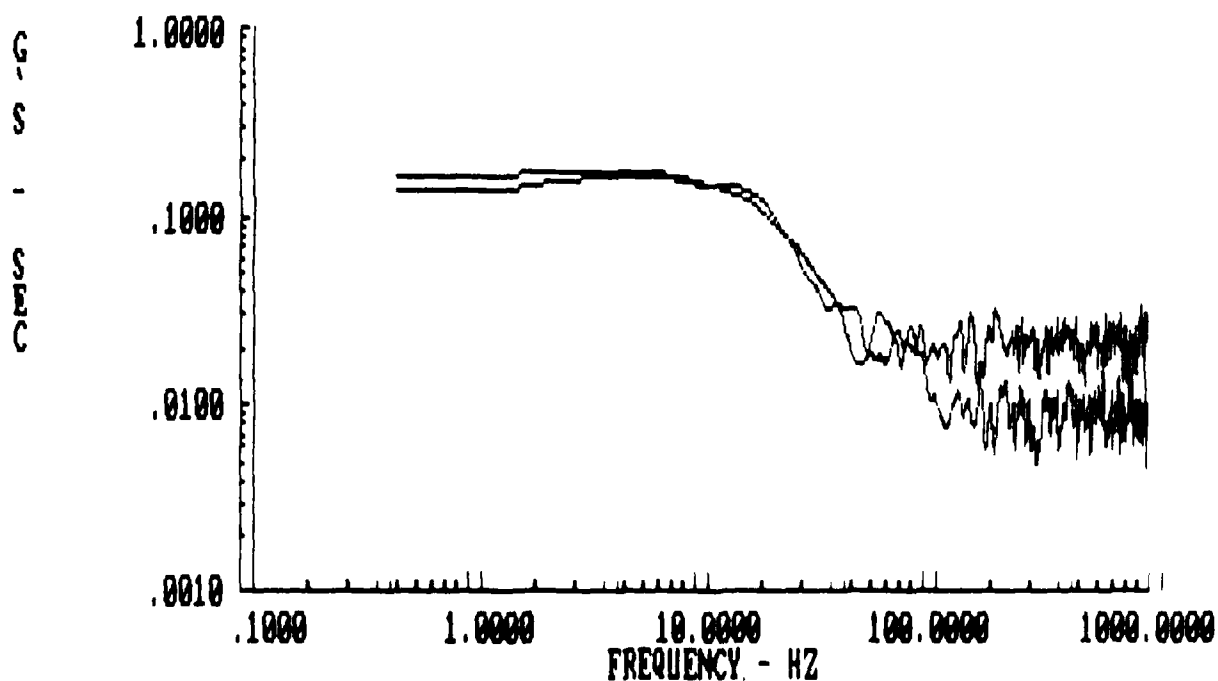
Figure 14. Fourier transforms (low g impact).

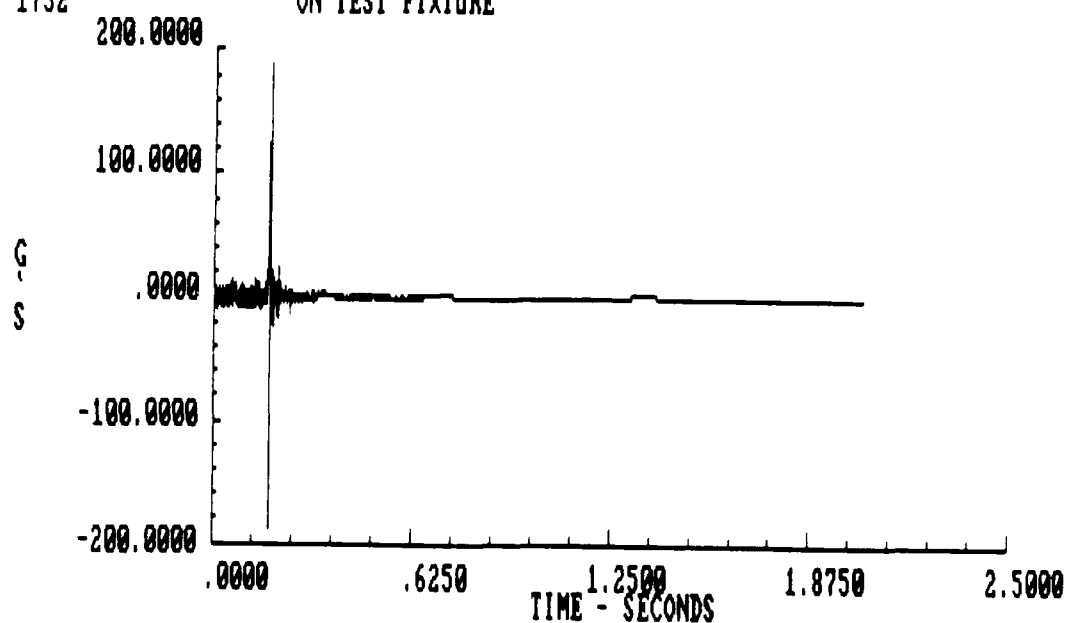
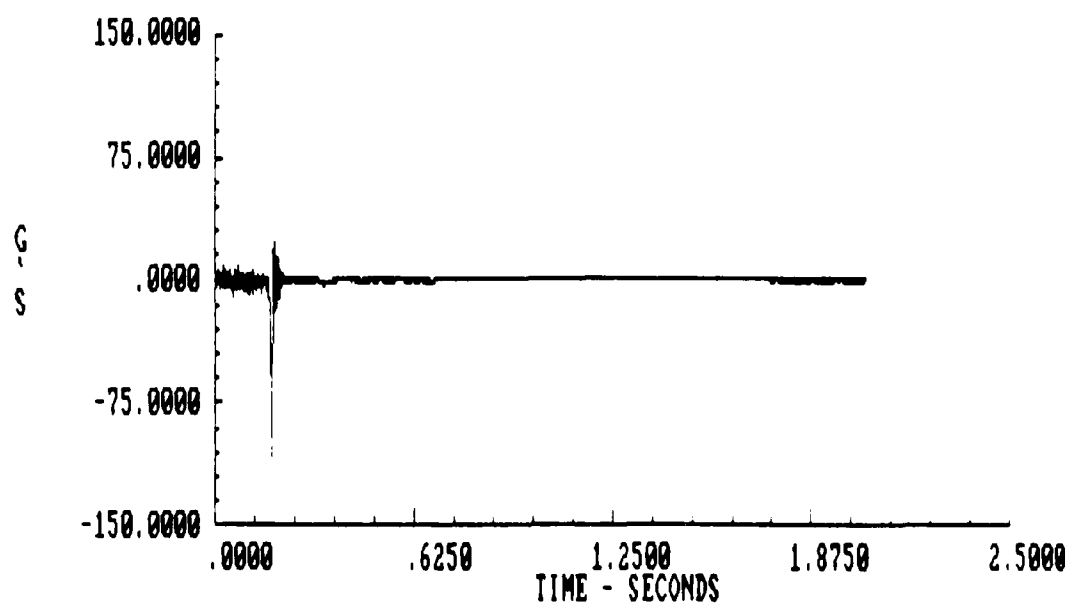
Figure 15. X-Y impact time history (high g).

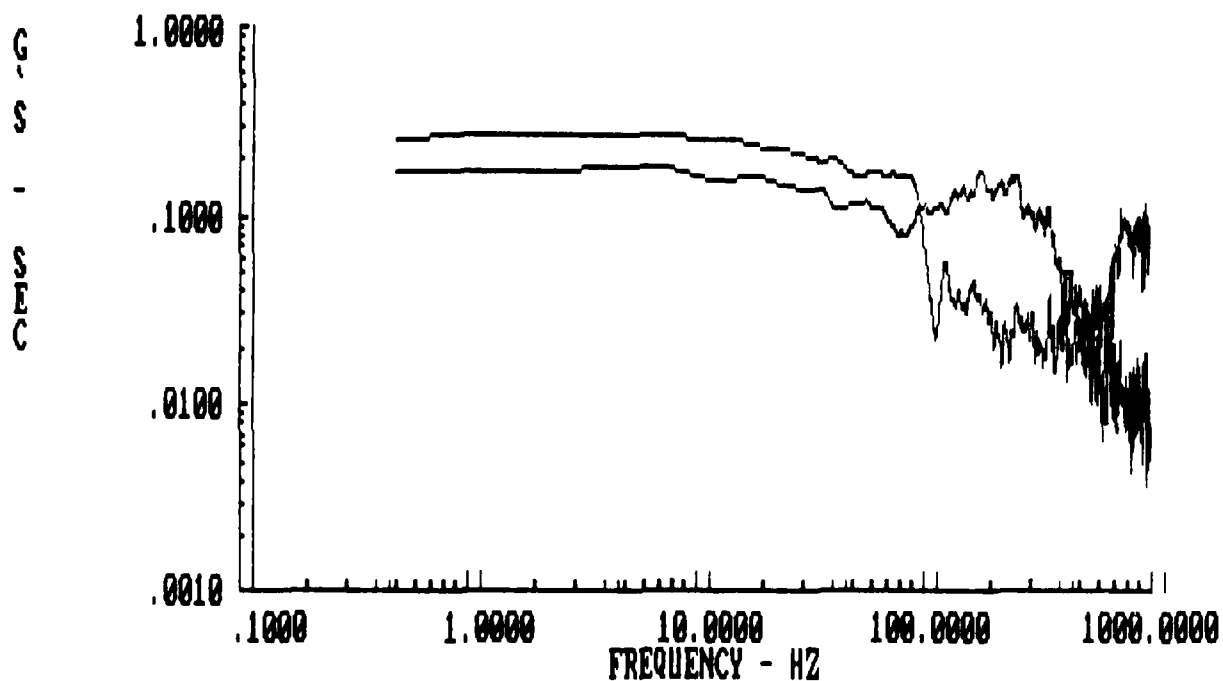
Figure 16. Fourier transforms (high g impact).

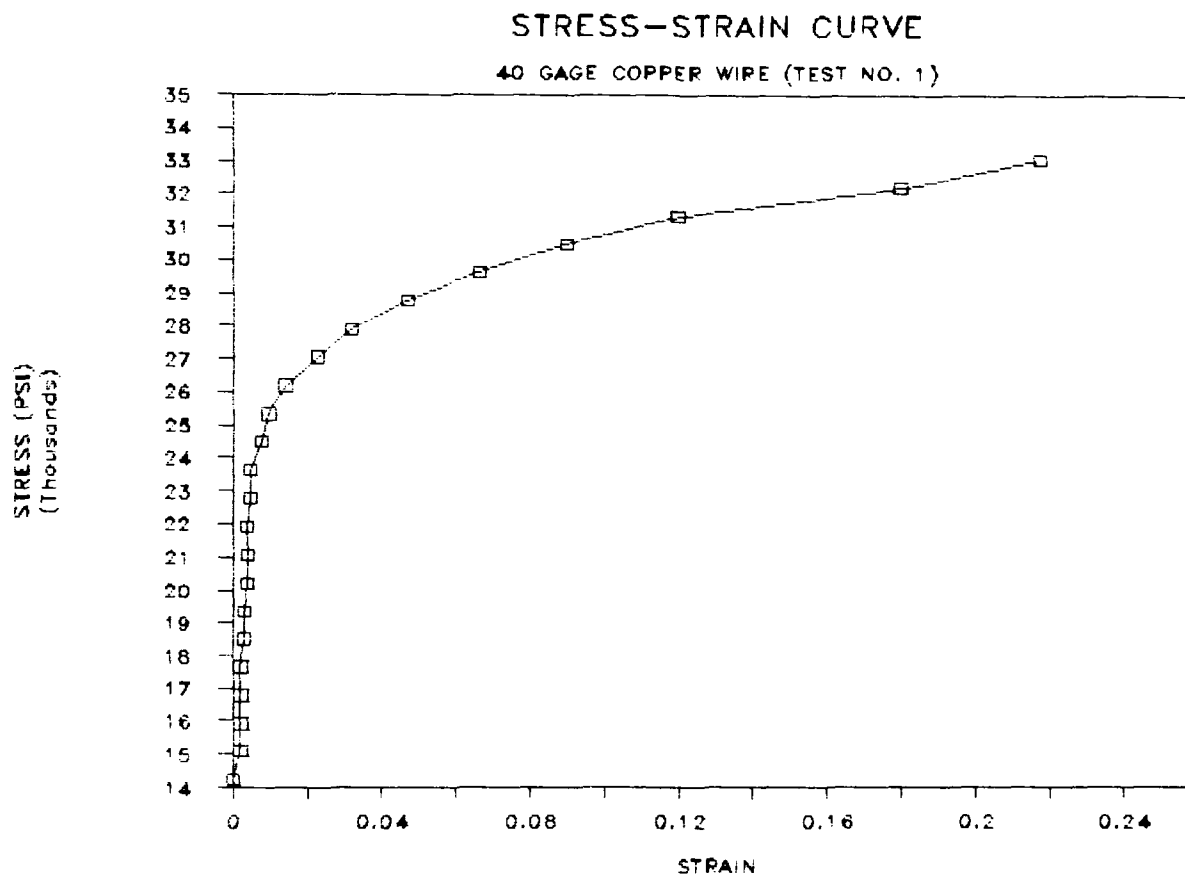
Figure 17. Tensile Test No. 1.

The tensile strength, ductility, and strain hardening characteristics of copper wire were investigated by performing four static loading tests. These characteristics should be identical for copper wires with similar compositions and therefore 40-gage was selected for testing, it being in the mid range of the sizes selected for use. Loading to failure was continuous in Tests 1 and 2, the loading rate being 1.5 grams/min. The resulting stress/strain relationships are shown in Figures 17 and 18. The same loading rate was used for Tests 3 and 4. However, the loading process was stopped and the accumulated load removed when the strain had reached approximately 5%. Loading was then recommenced and continued to failure. Figures 19 and 20 show the strain hardening effects of this loading procedure.

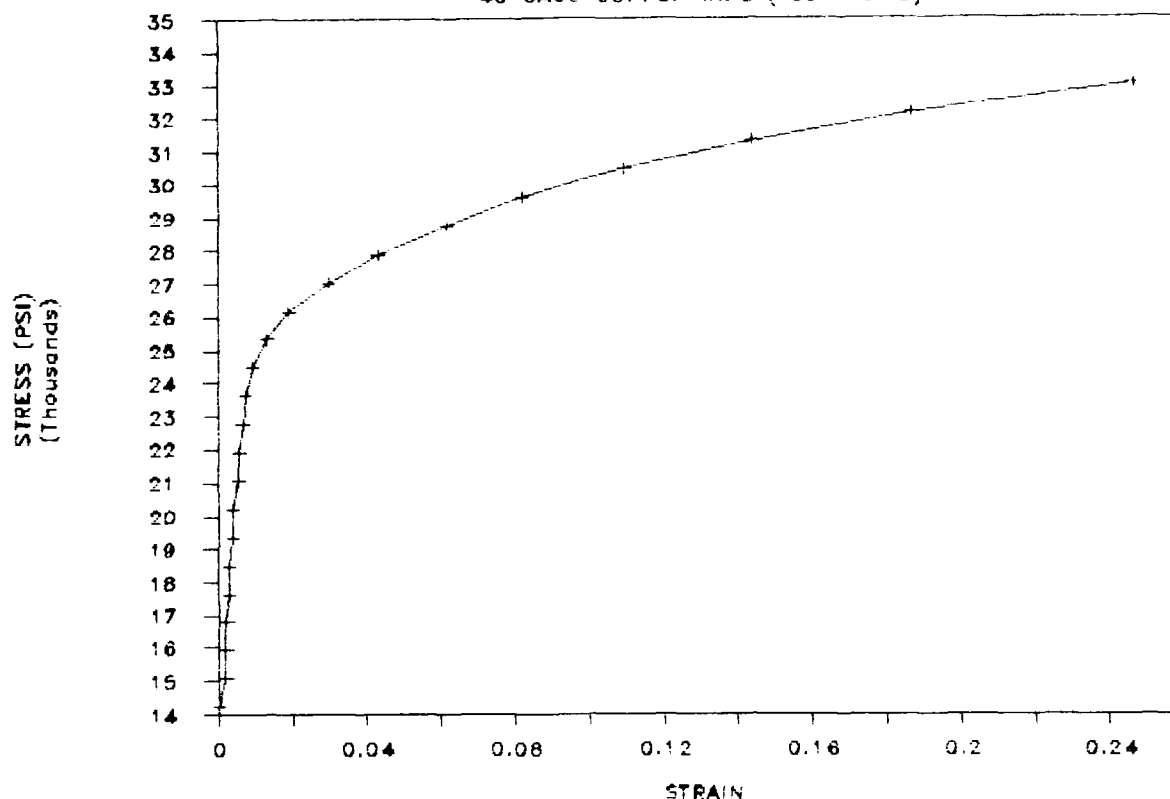
Figure 18. Tensile Test No. 2.

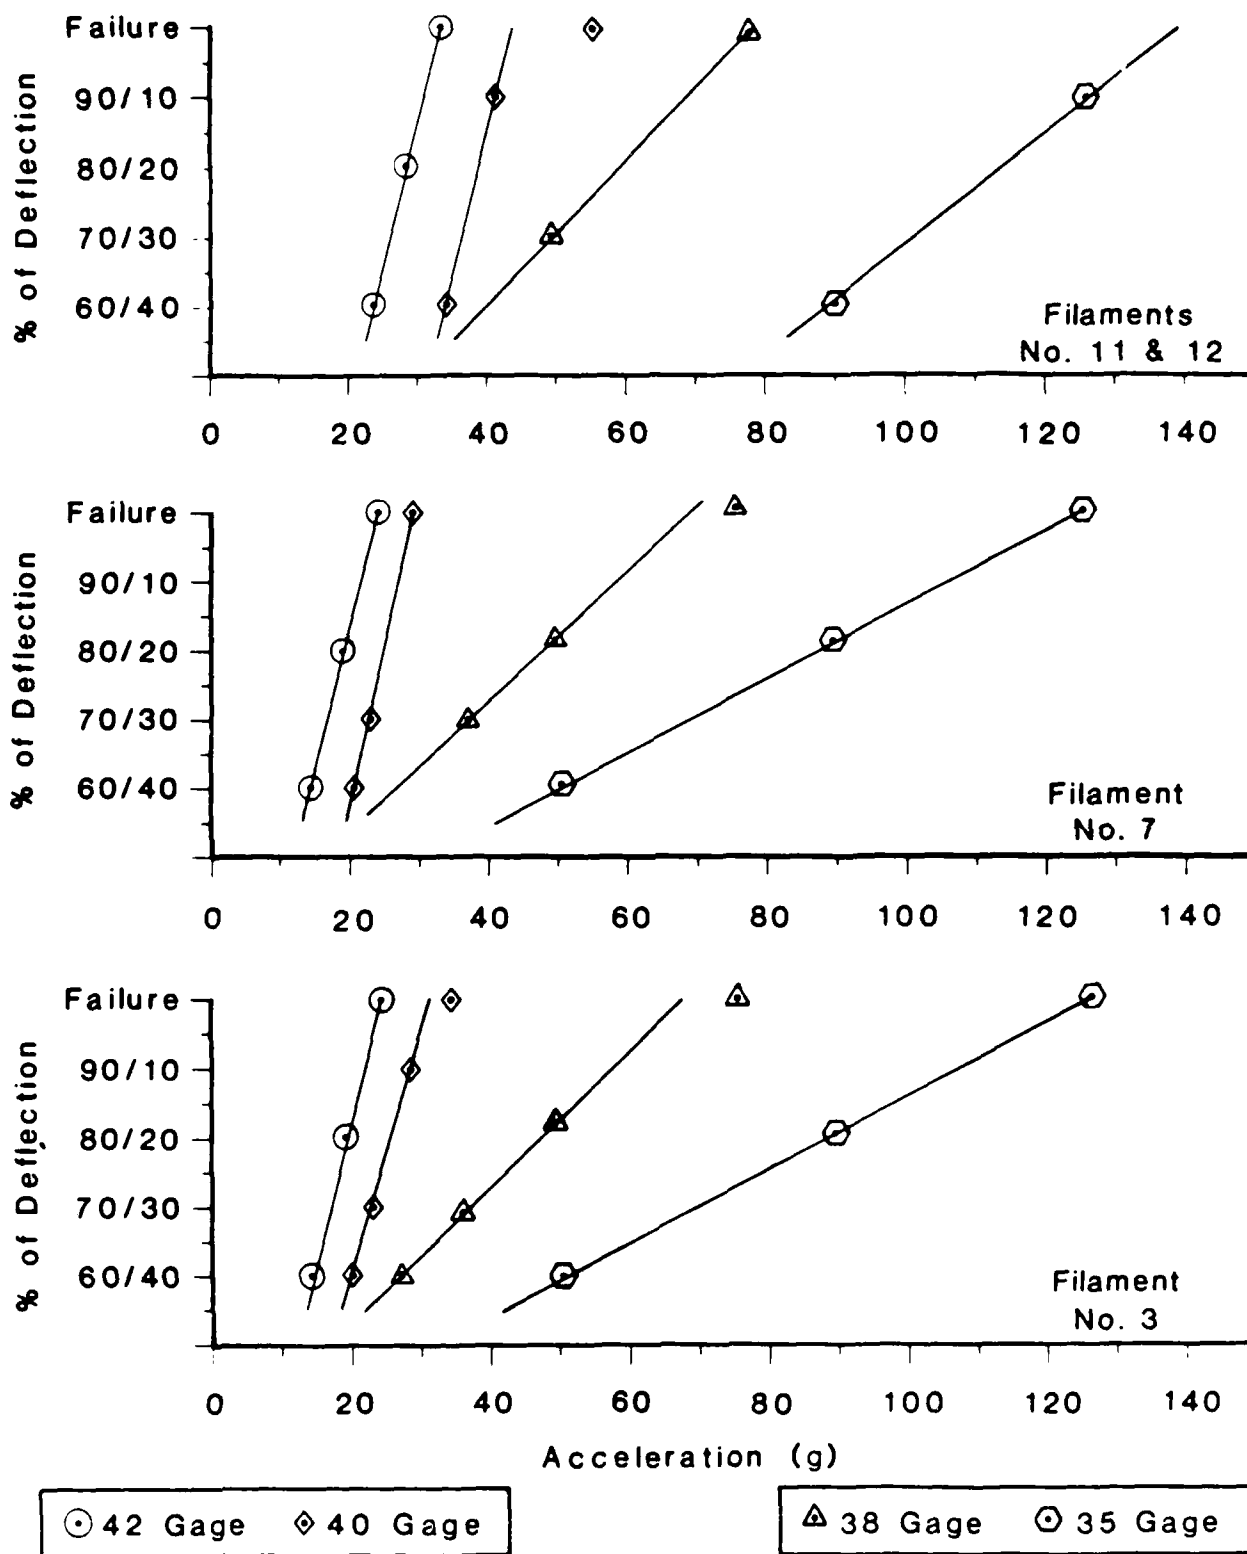
Figure 22. Conical slug deflection plots from Experiments 21, 22, 23 and 24.

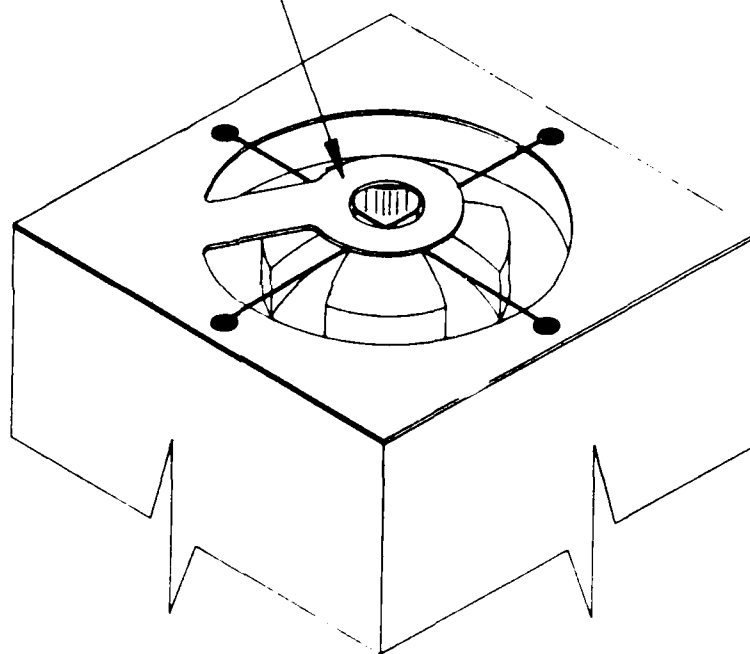
Figure 24. Spring clip arrangement.

The elimination of possible fatigue failures arising from prolonged exposure to low-level vibration was a critical design factor. It was achieved by the incorporation of a spring finger which establishes a minimum "g" threshold value below which the slugs do not move and, hence, do not stress the copper wire when subjected to low-level vibration. Extensive testing was conducted to verify that this arrangement provided the desired resistance to fatigue.

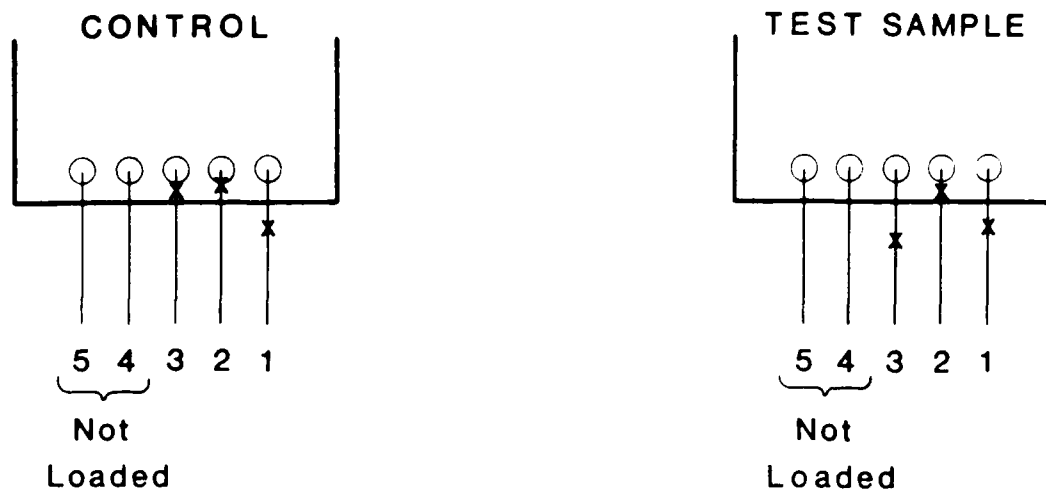
x = Point of failure

Dexter Hysol EA 956 AB was recommended by an adhesive company as an epoxy adhesive that was likely to meet the requirements of the application. The company also suggested a test procedure to verify that it was resistant to degradation from prolonged exposure to silicone oil. A test was performed in accordance with their recommendations. Two identical test samples (aluminum plates with five sensing wires epoxied to each) were prepared--one for testing purposes and the other a control (see Figure 25). The test plate was immersed in Amsoil synthetic gear lube oil (SAE 80W-90) and heated to 170°F and maintained at that temperature for 238 hours. This heating process accelerates any chemical reaction between the epoxy and oil by a factor of about 50 and, therefore, approximates over 1 year of service. Three wires on each sample were then subjected to static tensile loads until failure occurred. The results of the tensile loading are shown in Figure 26.

It was apparent that the strength of that adhesive bond between the plate and wire was not significantly reduced by the exposure to silicone oil, as all failures on the test sample were wire breakages.

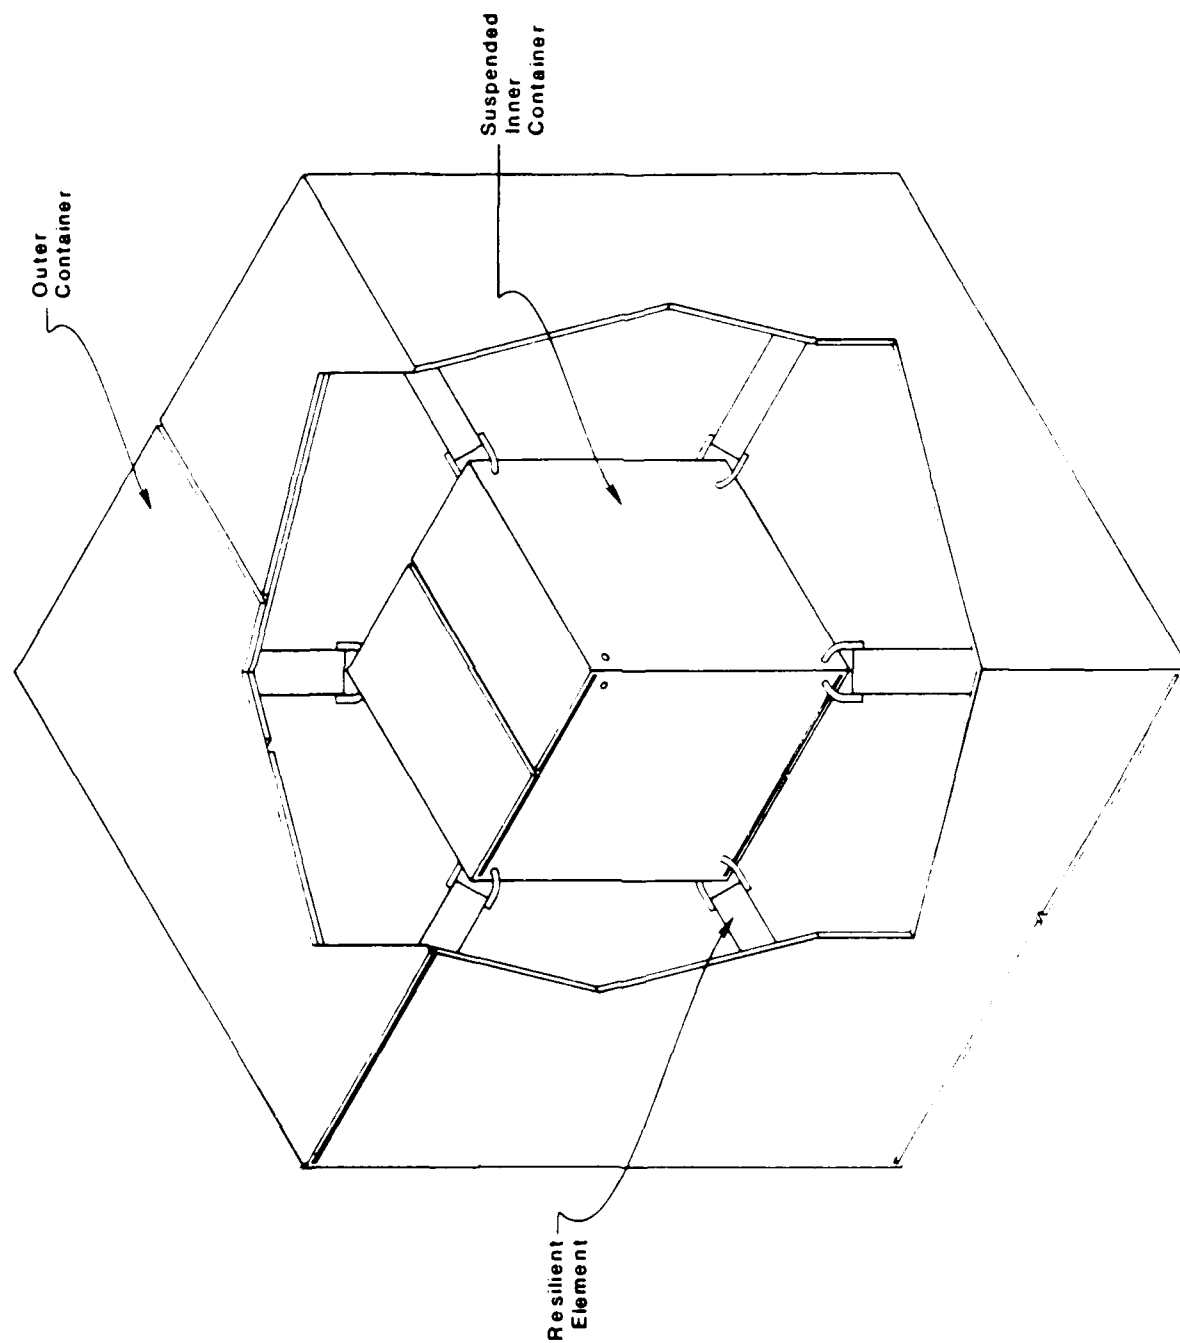
Figure 27. Transit packing concept.

Success was achieved by suspending the conical fixture centrally within a 9-inch cardboard box with resilient elements. The fixture remained unaffected after the box was dropped repeatedly from a height of 10 feet. The general concept of the transit packing suggested for the PAD sensor is shown in Figure 27. This technique appears adequate for protecting the product during shipment.

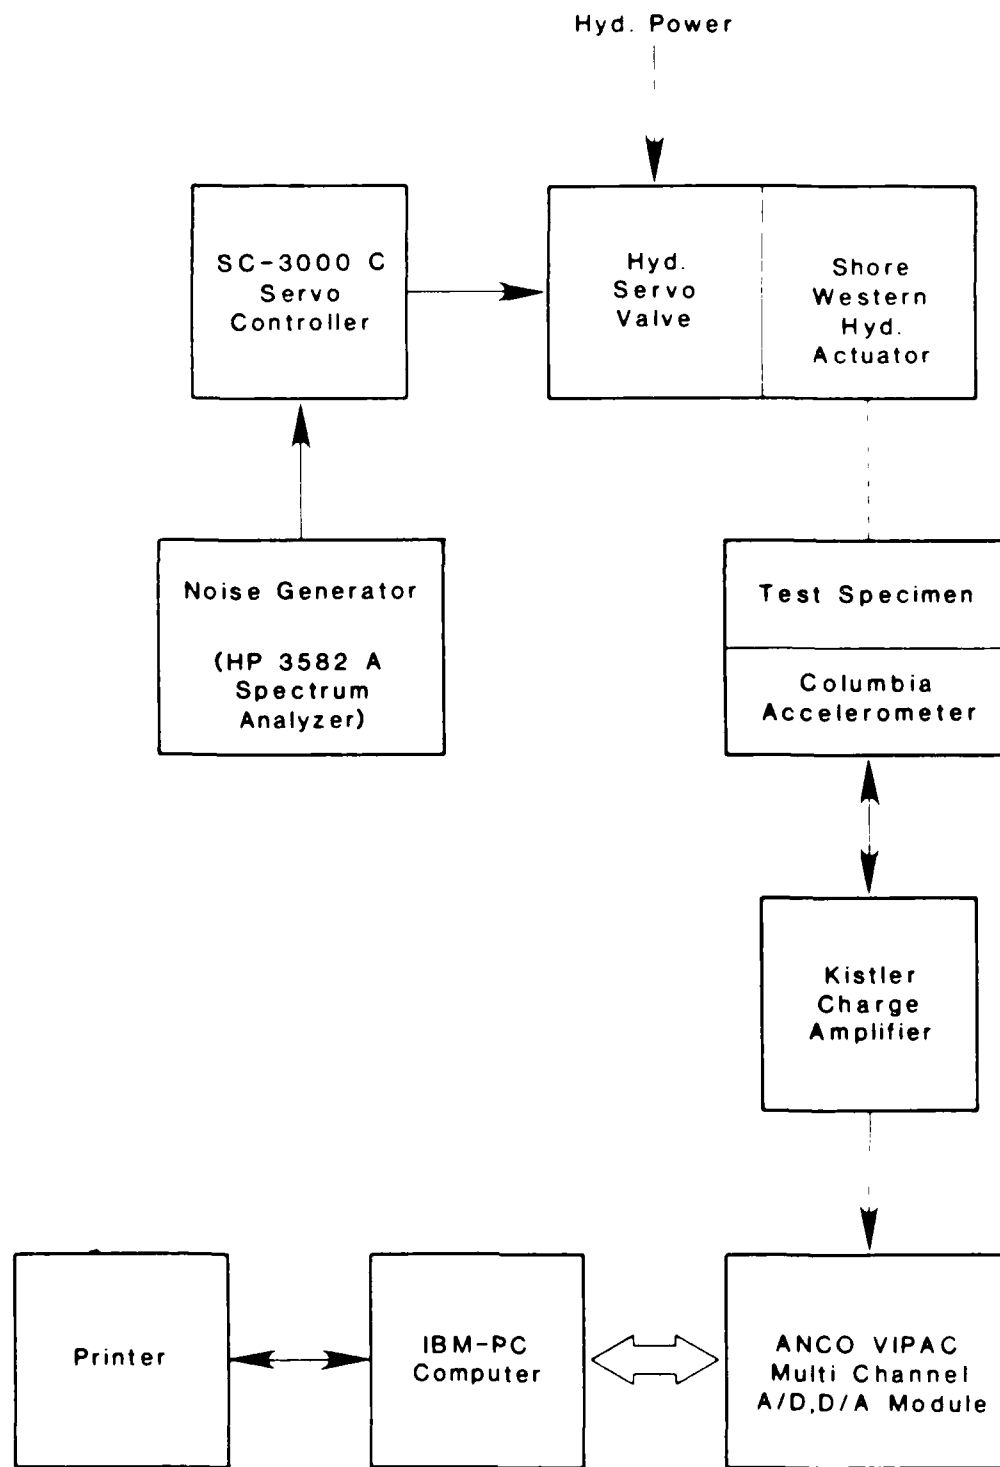
Figure 30. Block diagram of vibration testing system.

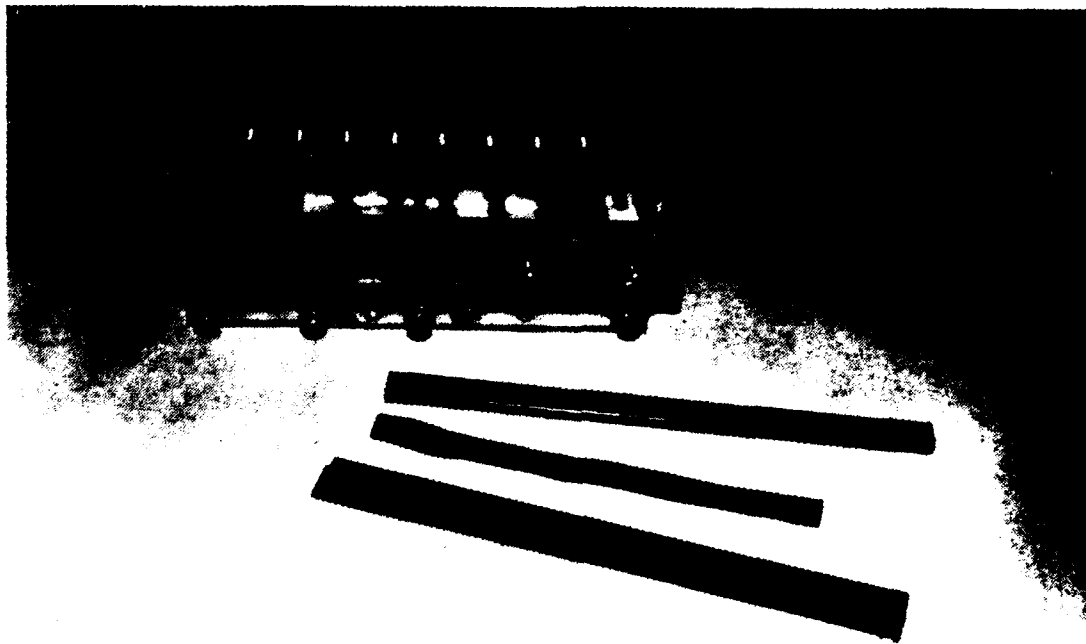
Figure 31. Cylindrical slug test fixture.
